SVHSER16000,  
REVISION: Basic  
DATA RIGHTS: N  
DATE: July 14, 1995

# SPACE STATION WATER PROCESSOR PROCESS PUMP

## Final Report

United Technologies Corporation

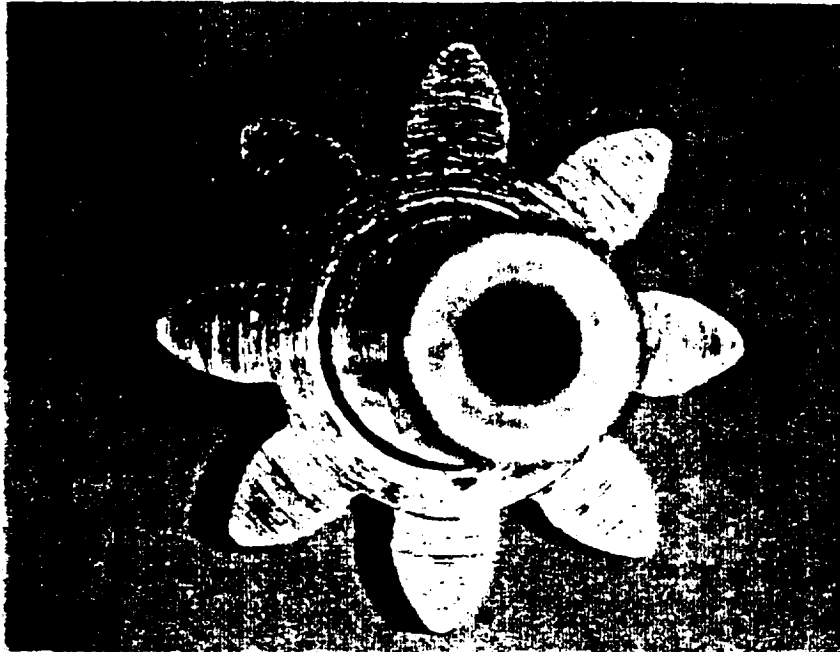
**FIGURE 2:** TOP: Bottom plate side of the 718 drive gear showing scoring and what appears to be non-symmetrical involutes.  
BOTTOM: Bottom plate showing scoring in the area that interfaces with the 718 drive gear.

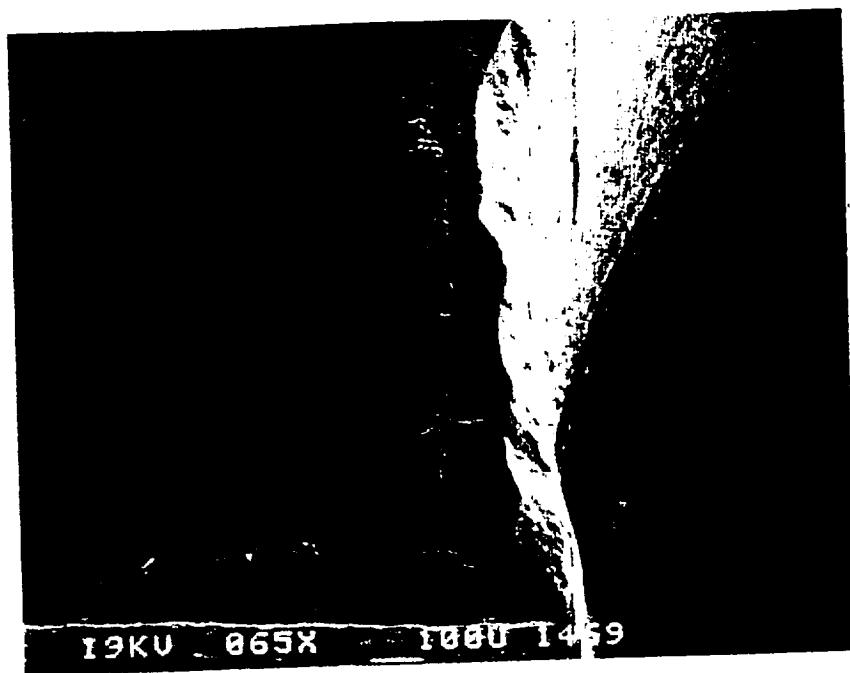
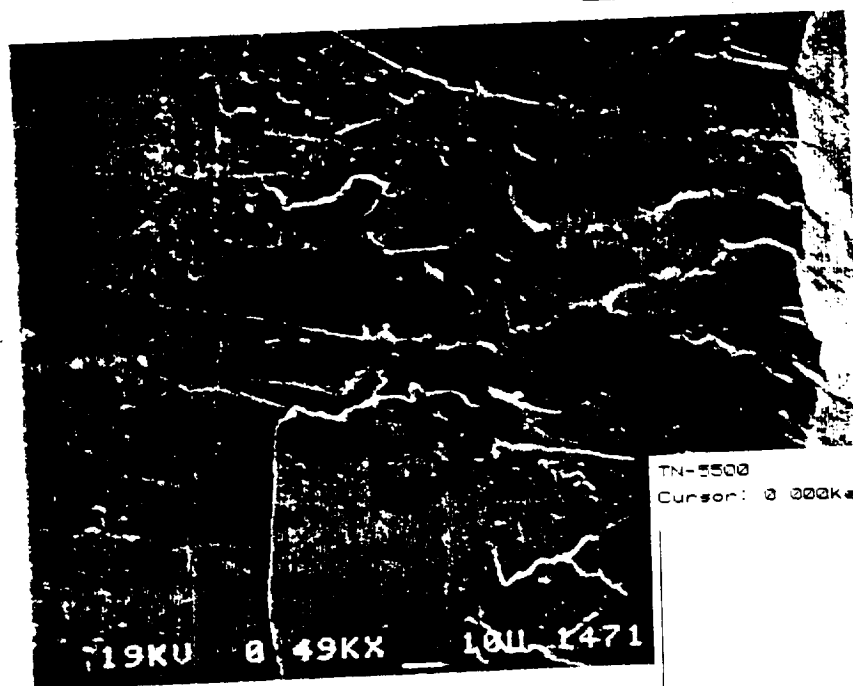
**FIGURE 3:** Bottom plate at the 718 drive gear interface showing scoring and transferred material. The EDX analysis for the indicated area of transferred material is also shown.

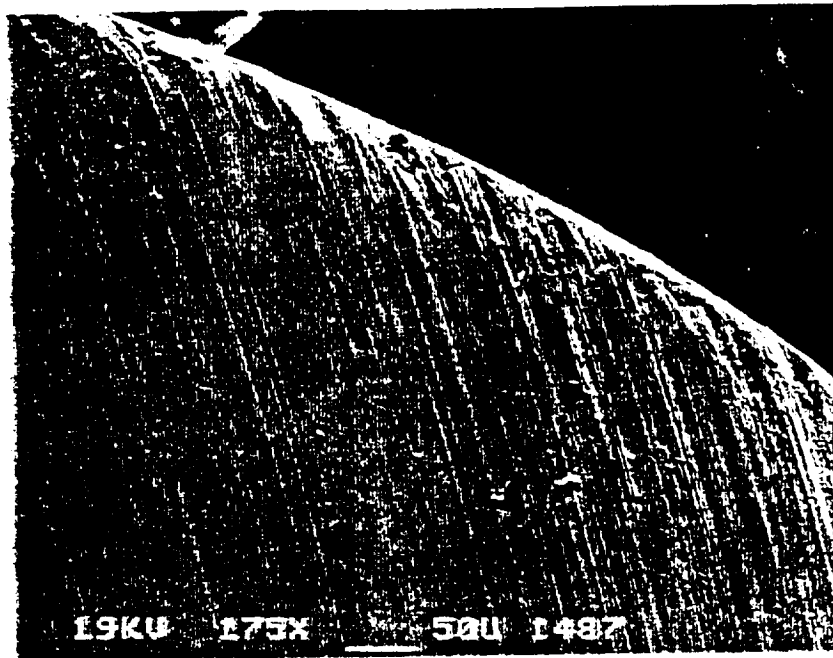
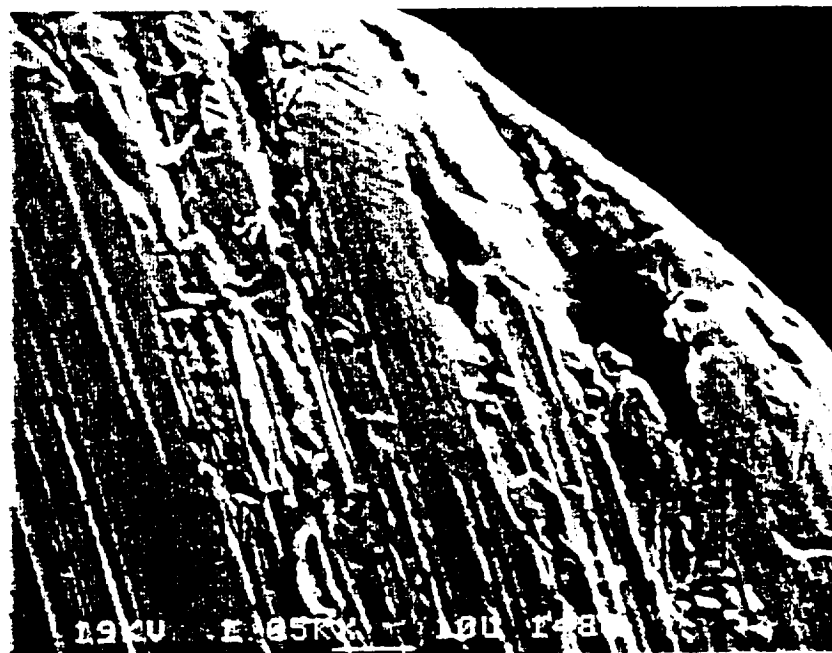
**FIGURE 4:** The bottom plate side of the 718 drive gear showing severe scoring and damage to the leading edge of the tooth.

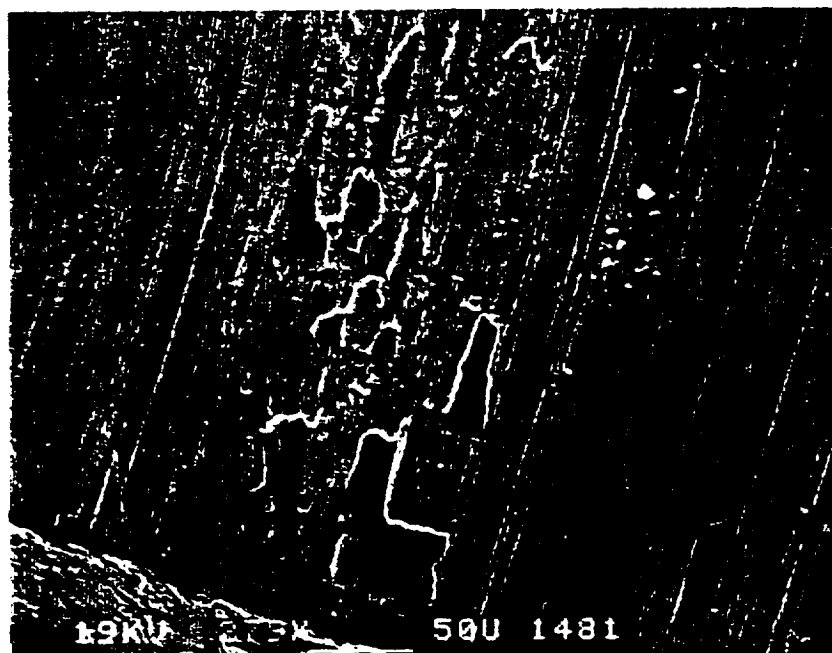
**FIGURE 5:** Bottom plate side of the 718 drive gear showing areas of smeared metal.

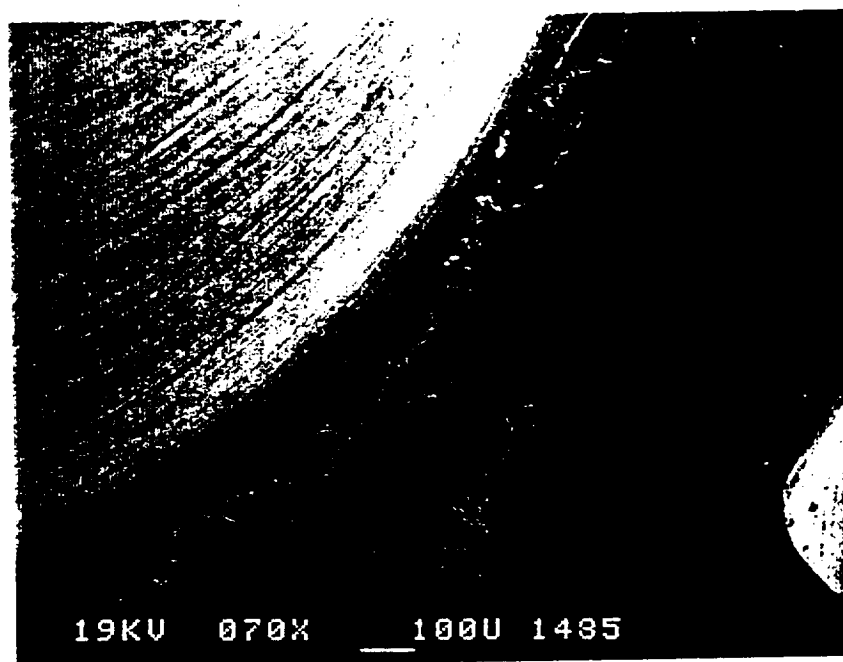
**FIGURE 6:** Bottom plate side of the 718 drive gear showing the "stepped" surface at the ID of the teeth.

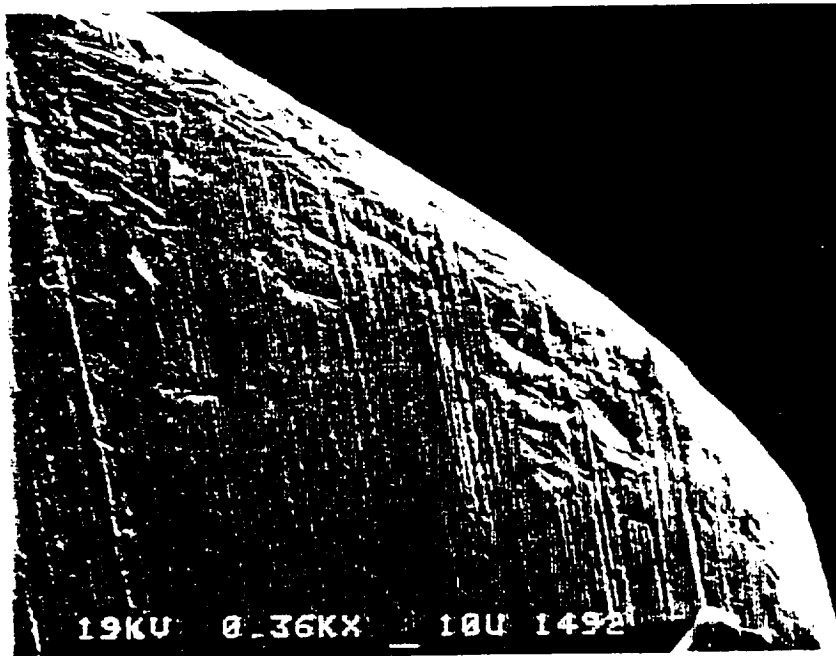
**FIGURE 7:** Top plate side of the 718 drive gear showing minor scoring and minor damage to the leading edge of the tooth.

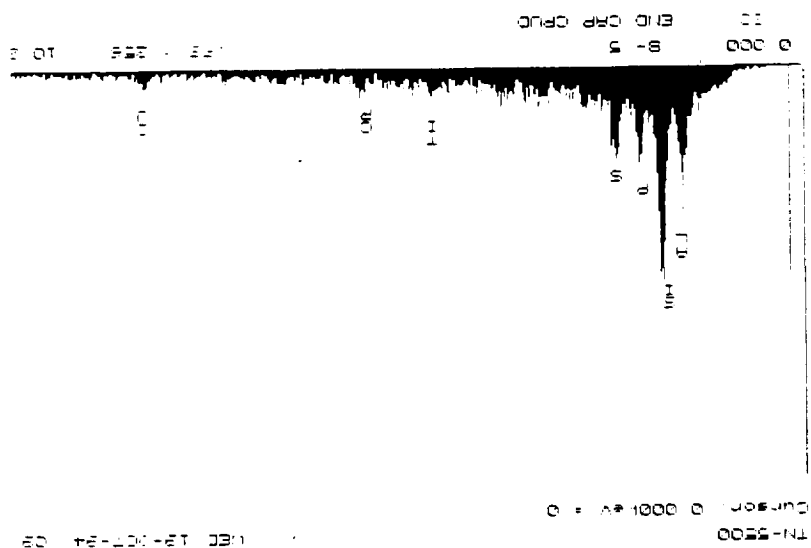
**FIGURE 8:** End cap from the 15-5 gear cartridge showing the black-brown contamination. An EDX analysis of the contamination is also shown.

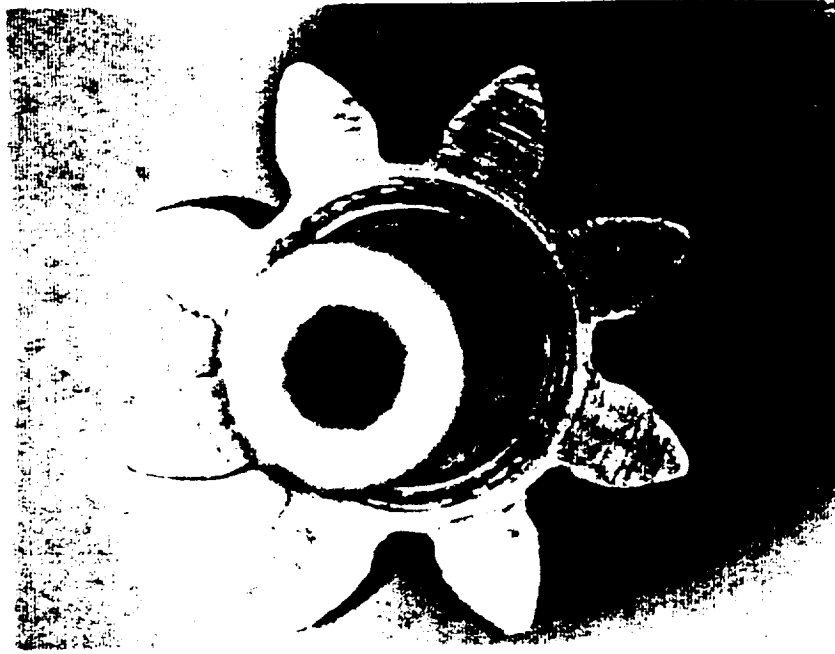
**FIGURE 9:** 15-5 drive gear showing scoring of the bottom plate side (top photo) and of the top plate side (bottom photo).

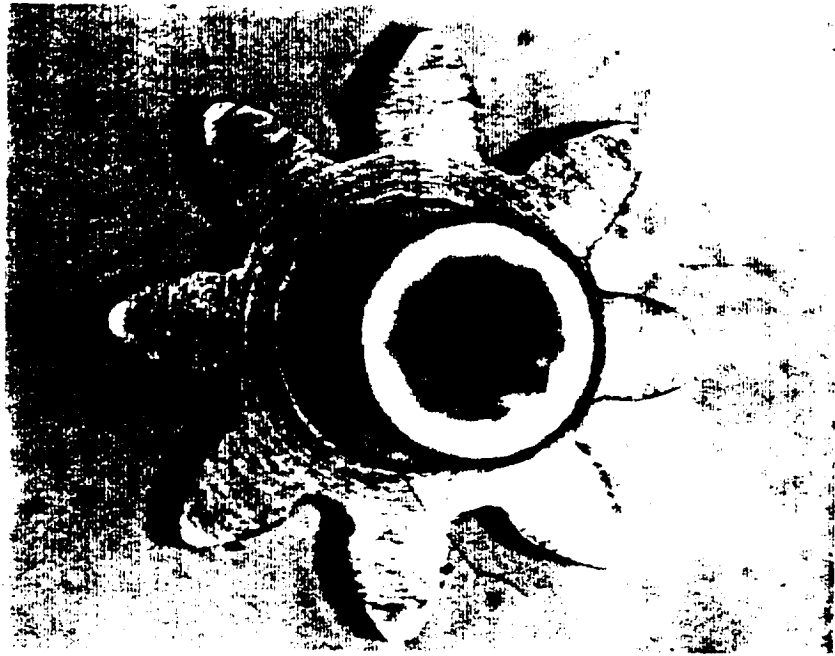
**FIGURE 10:** 15-5 driven gear showing scoring of the bottom plate side (top photo) and of the top plate side (bottom photo).

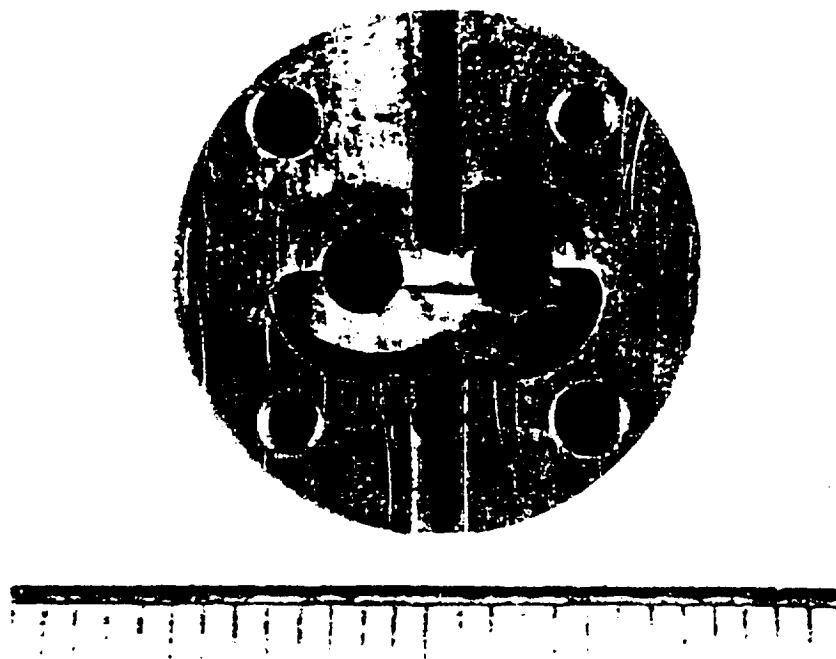
**FIGURE 11:** TOP: Bottom plate showing scoring at the interfaces with the 15-5 gears.  
BOTTOM: Top plate showing scoring at the interfaces with the gears.

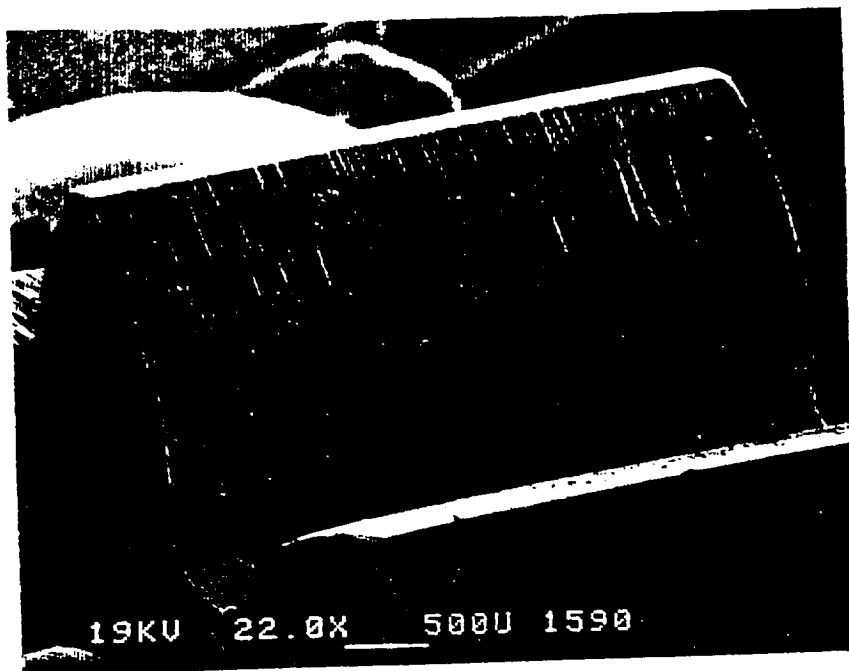
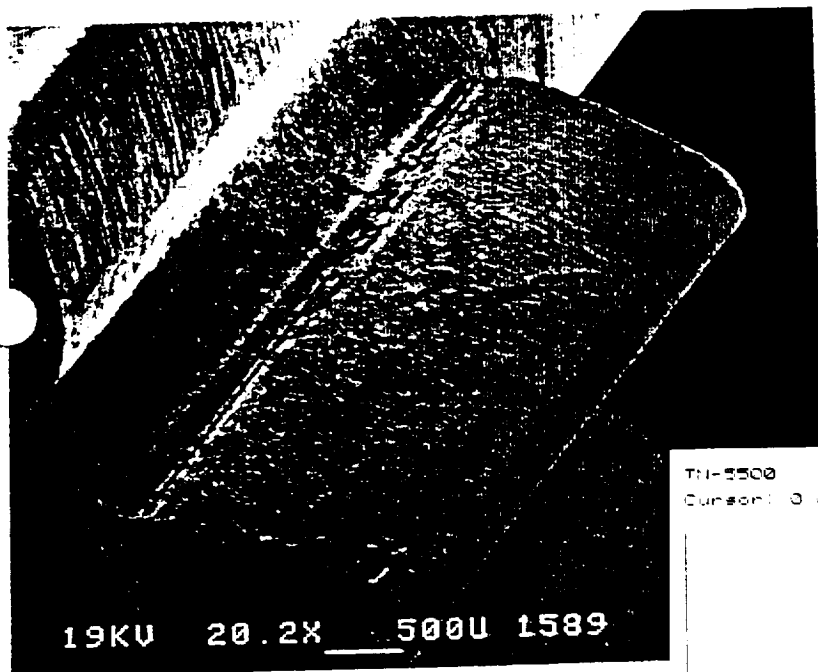
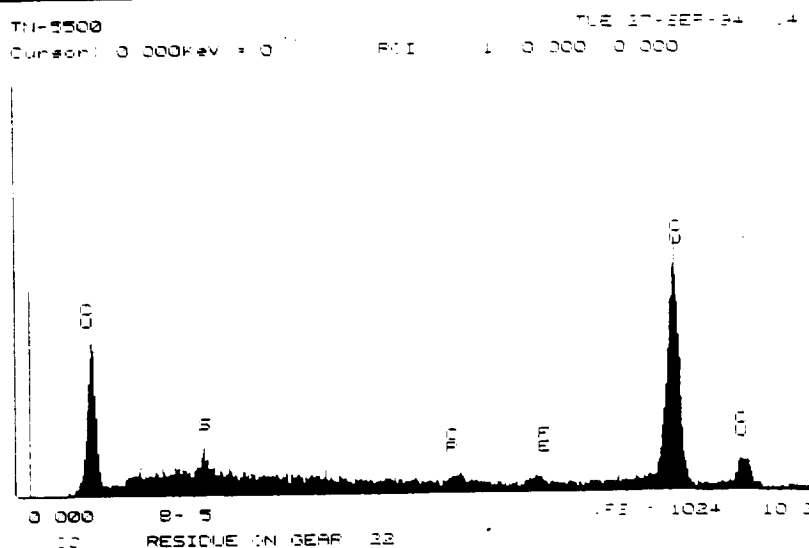
**FIGURE 12:** 15-5 drive gears showing wear damage on the drive faces (top photo) and collected contamination on the non-driven faces (bottom photo). An EDX analysis of the contamination is also shown.

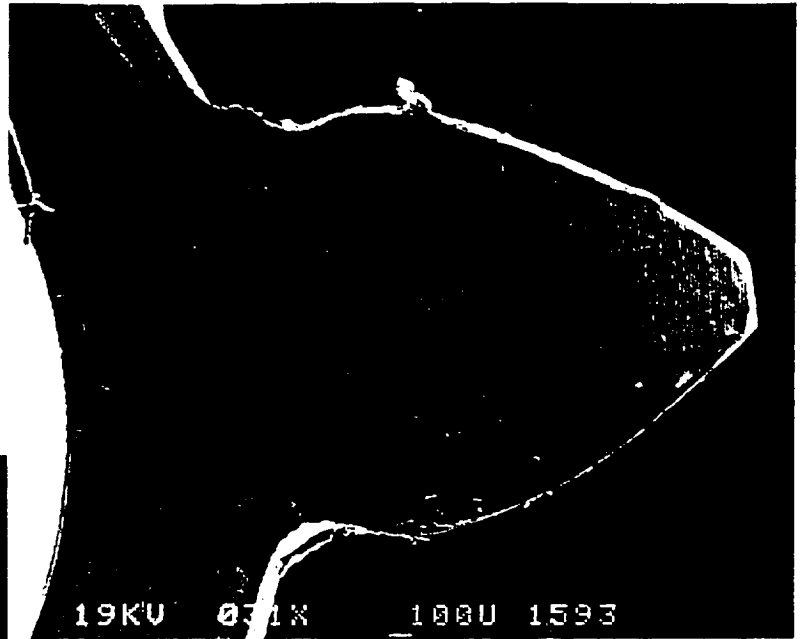
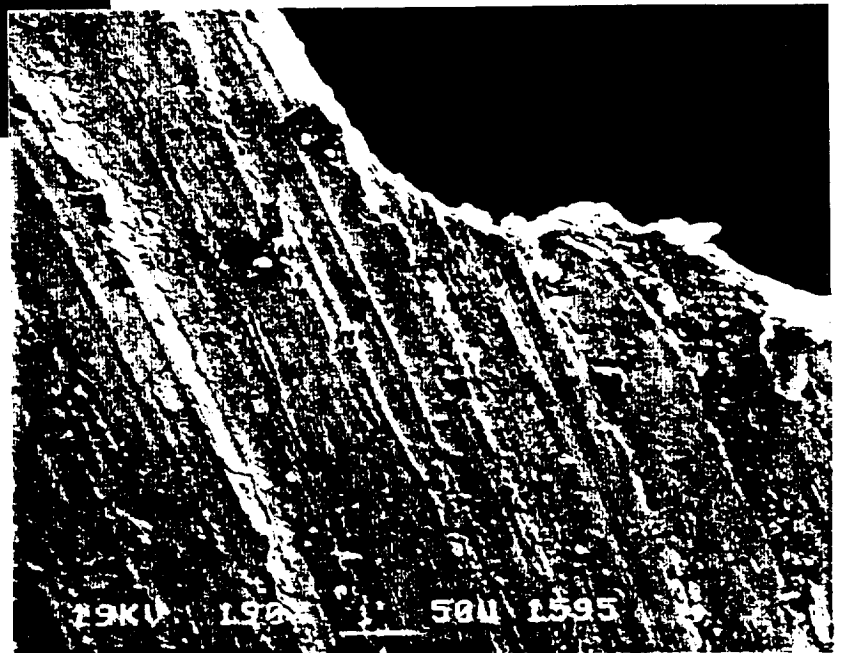
**FIGURE 13:** 15-5 drive gear showing scoring of the bottom plate side. Note that there is no damage to the leading edges. Also, note the “stepped” appearance near the ID of the teeth.

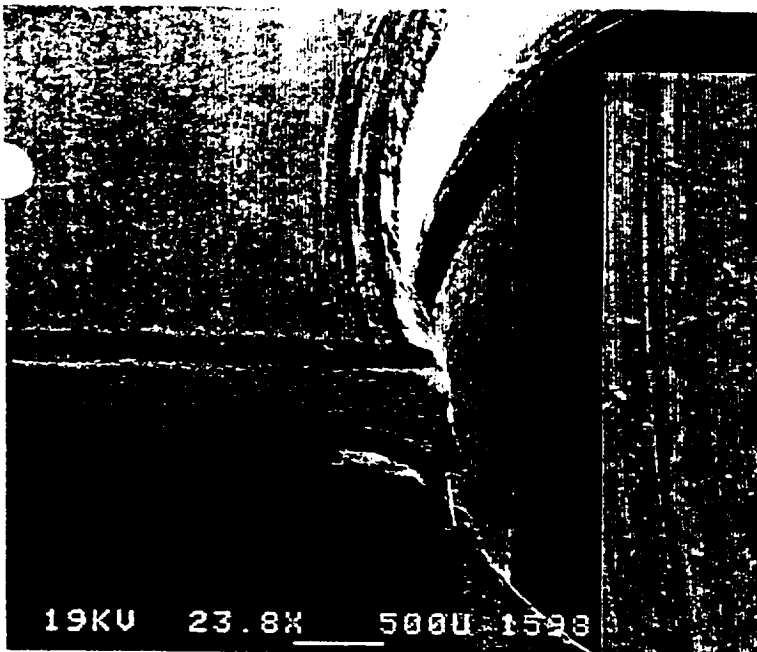
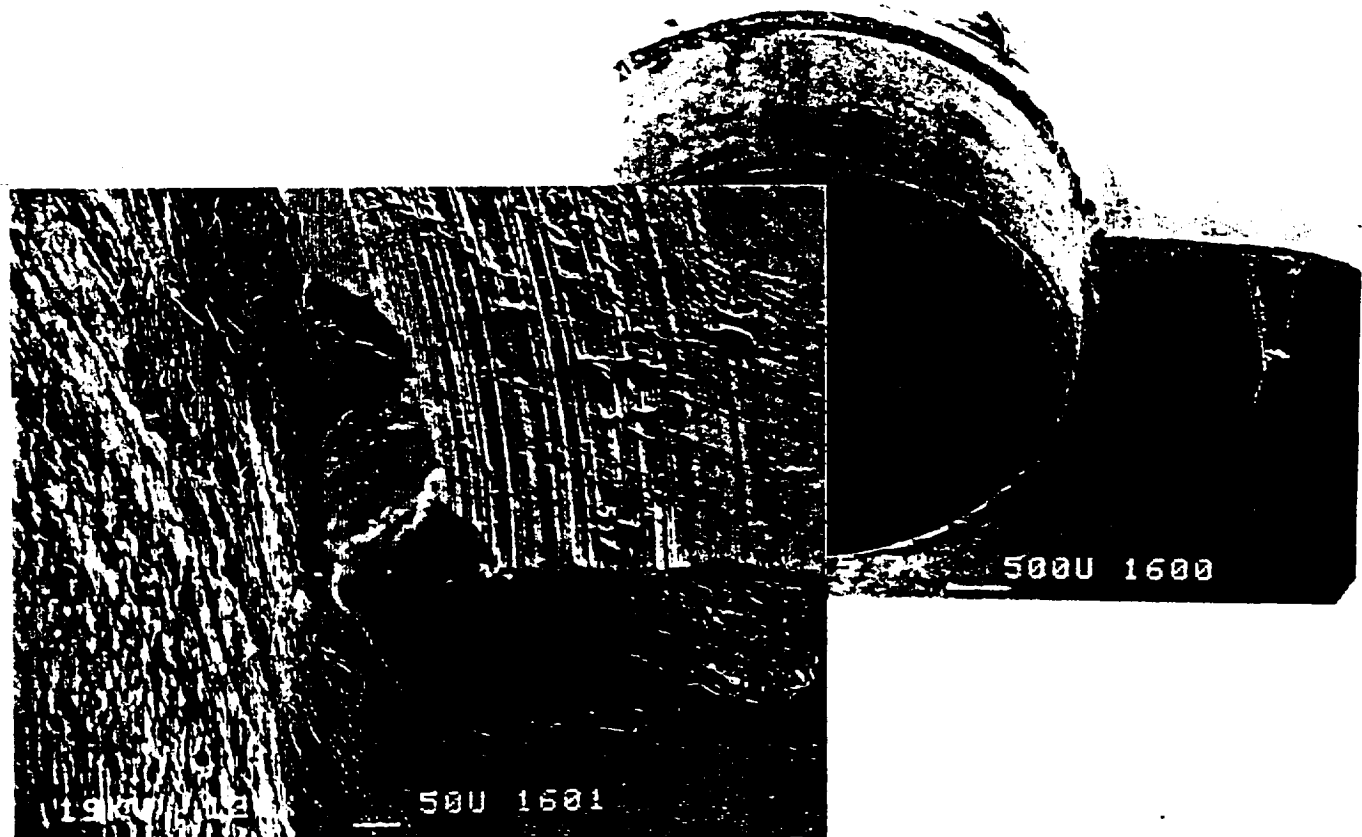
FIGURE 14: Bottom plate showing scoring at the interface with the 15-5 drive gear.

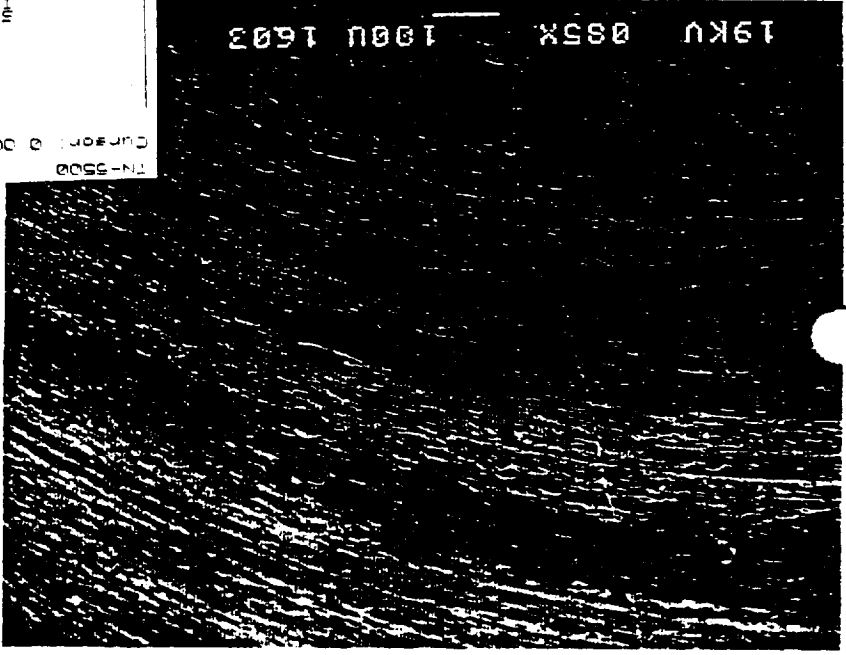
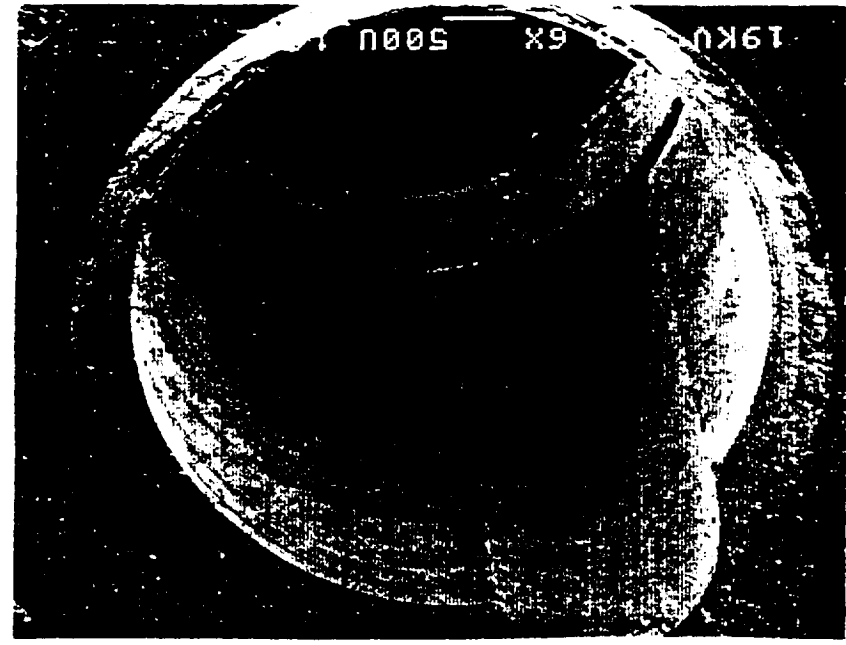
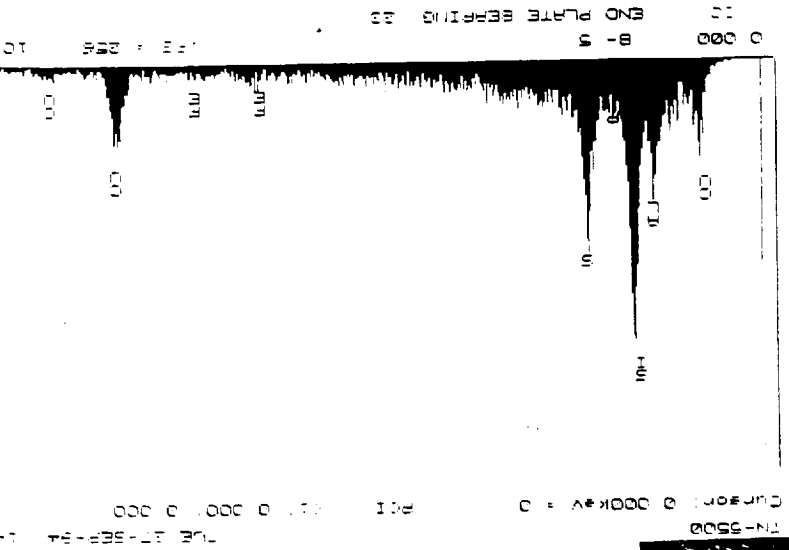
**FIGURE 15:** Typical area of the journal bearings from the 15-5 gear cartridge showing circumferential scoring. A typical EDX analysis of the journal bearing material is also shown.

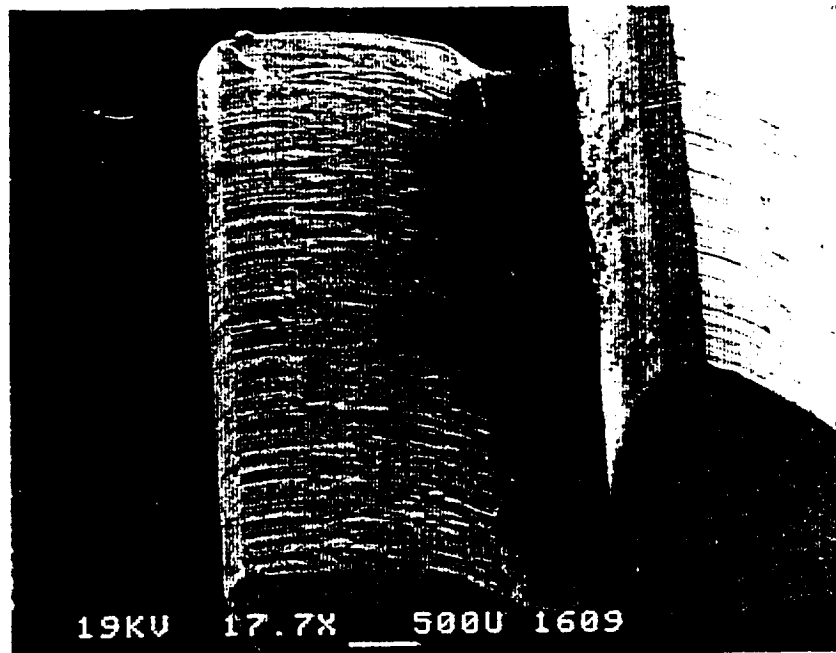
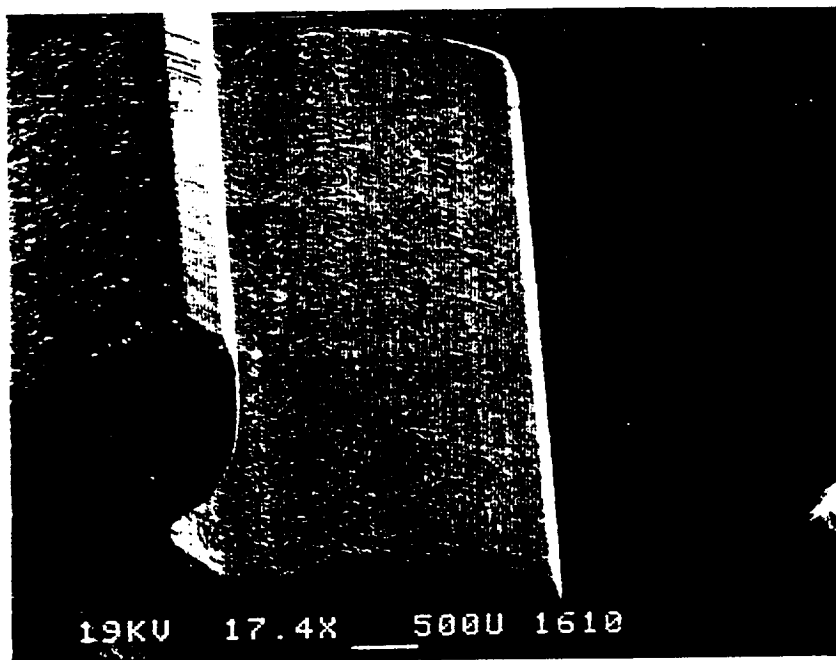
**FIGURE 16:** 15-5 driven gear showing wear damage on the driven faces and collected contamination on the non-driven faces.

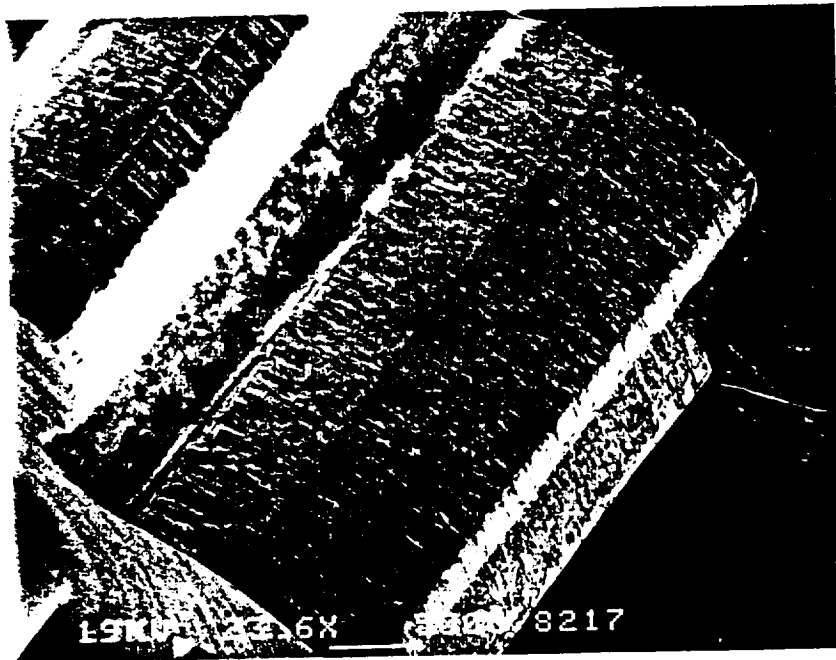
**Figure 1:** Top: Optical photo at 8x showing the wear present on the gear teeth of the low speed 15-5 gears following pump testing.  
Bottom: SEM photo at 23.6x showing the wear present on the gear teeth of the low speed 15-5 gears following pump testing.

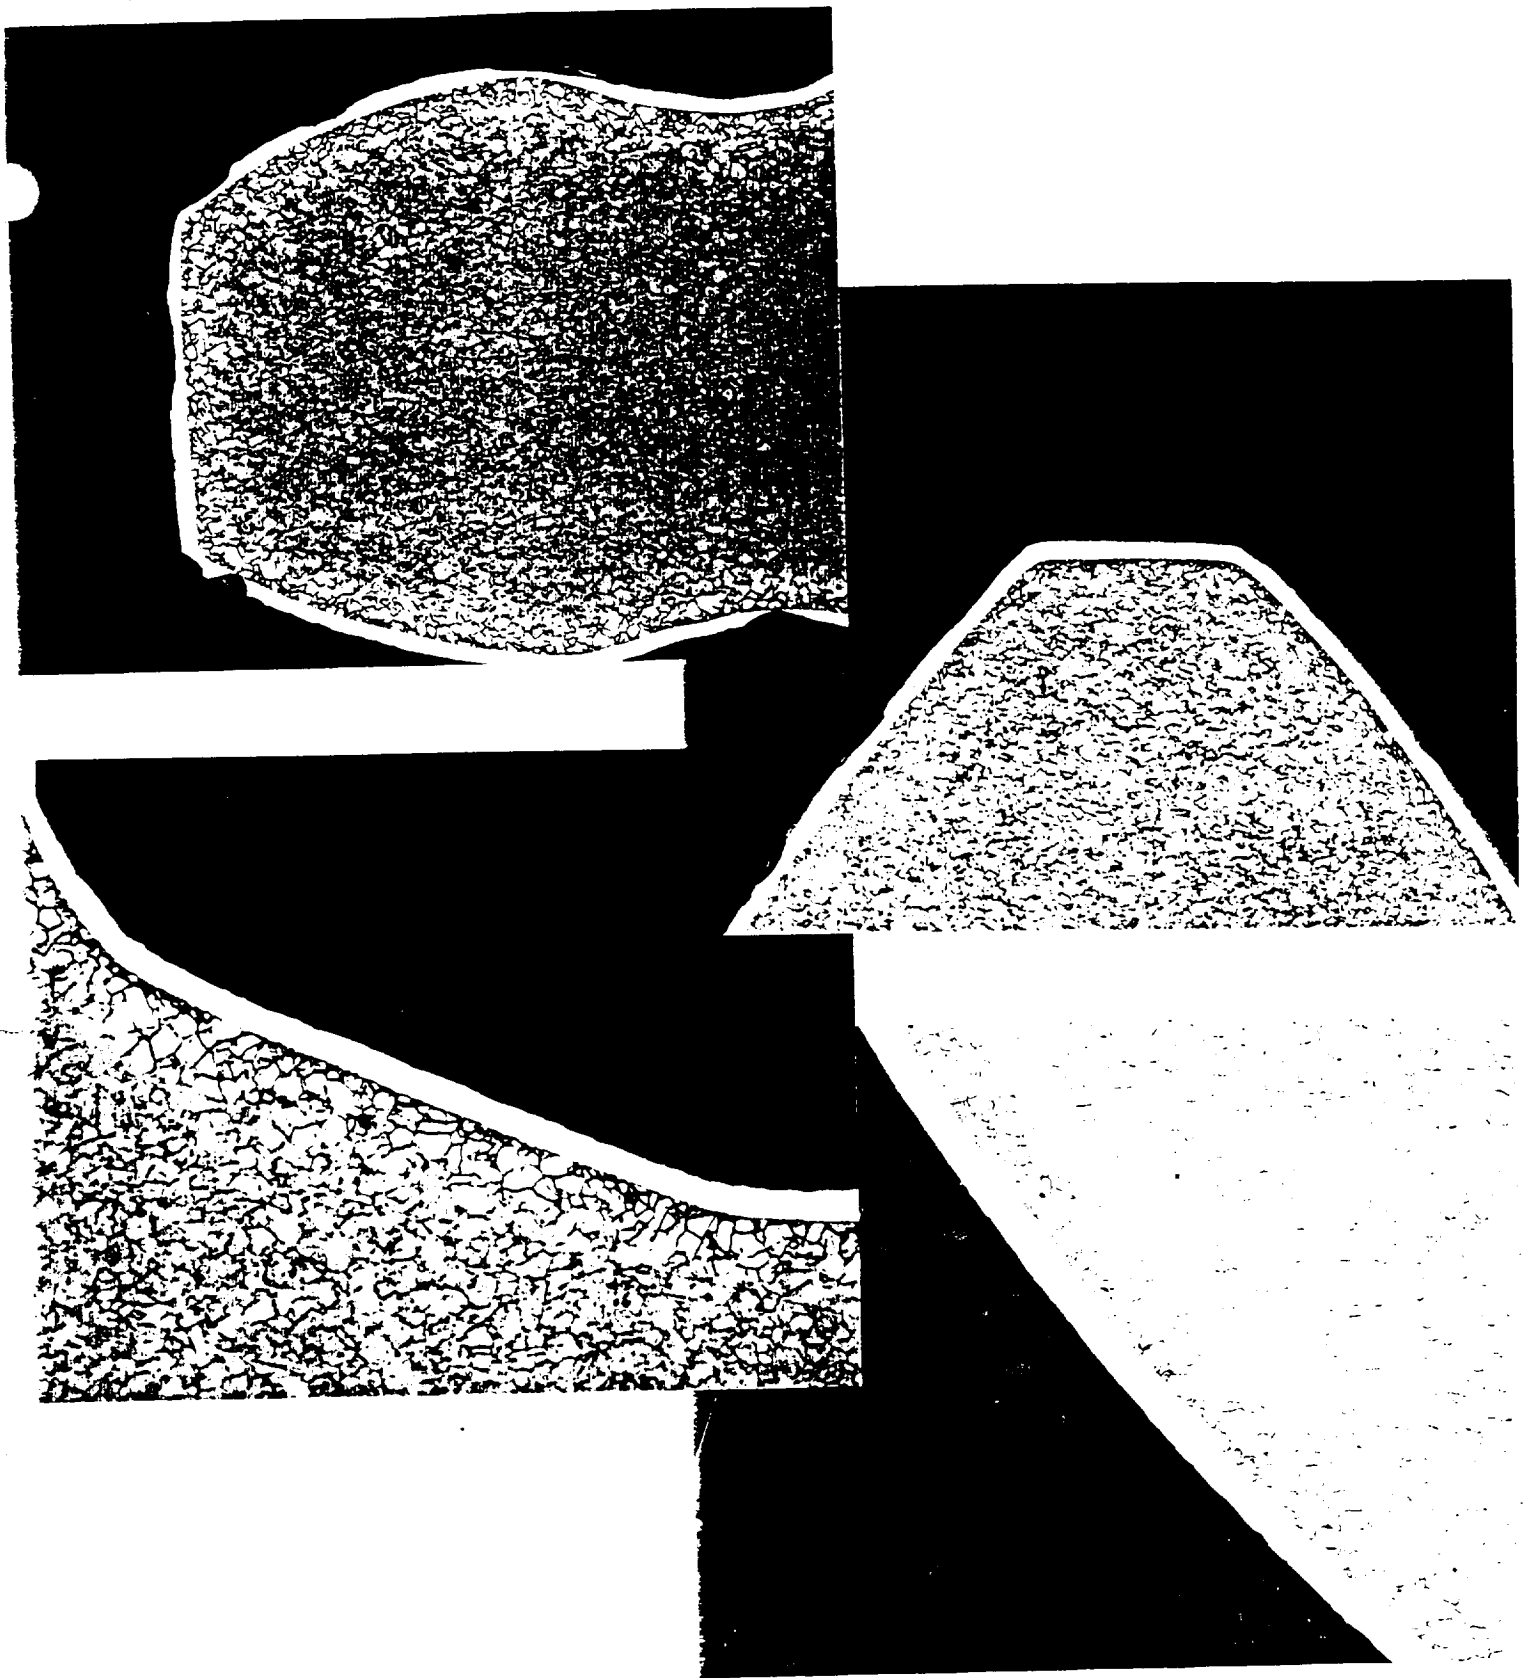
**Figure 5:** Optical photos at of the metallographic cross-section of the over-sized borided 718 gear. From top to bottom are areas of a spline at 100x, a gear tooth tip at 100x, a gear tooth root at 200x, and a journal diameter at 200x.

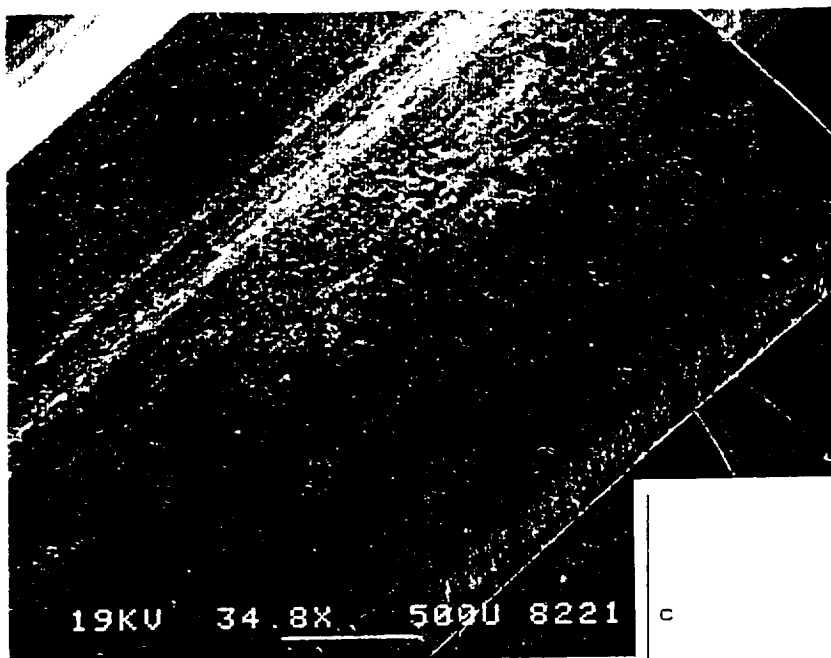
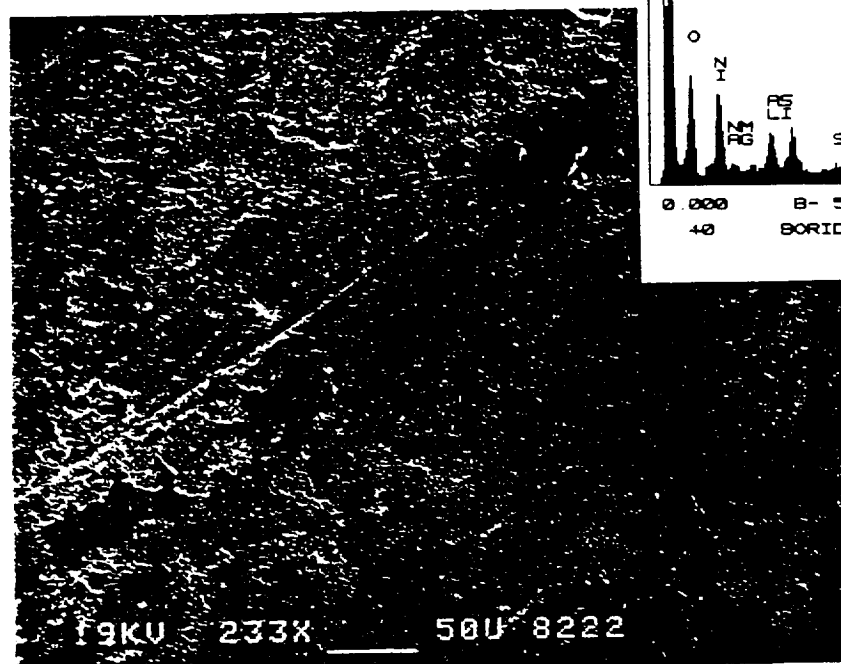
**Figure 6:** SEM photos at 34.8x and 233x of the surface of the over-sized borided 718 gear. An EDX analysis of the deposit material is also shown.

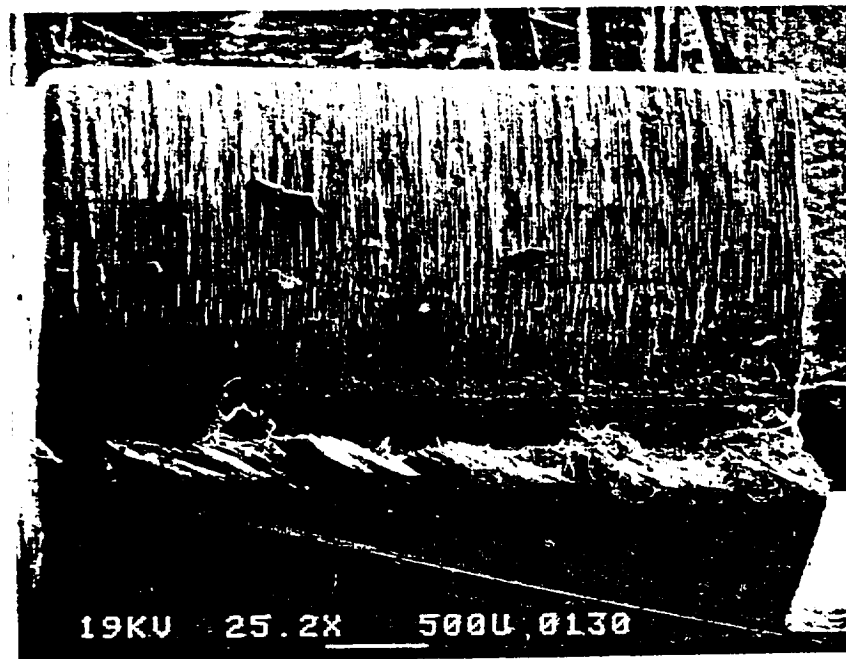
A teardown and inspection was conducted which revealed significant damage to the gear drive faces. This damage was similar to that found on the Inconel 718 gears. Upon the metallurgical examination it was found that the boride layer on the gear drive faces had been removed. Once the Borided surface was removed wear of the gears occurred. The wear/damage to the gears caused an increase to the pump backlash which is believed to have caused the gauge instability and increased pump vibration and noise. This increased backlash also is believed to have caused the decrease in pump performance.

**Figure 1:** Typical teeth from the 718 drive gear showing significant wear of the drive faces.

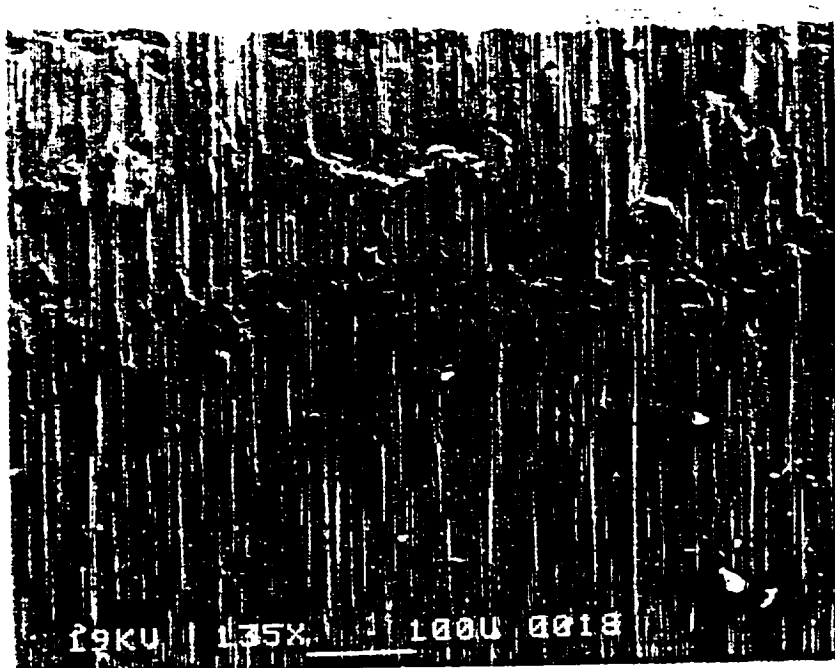
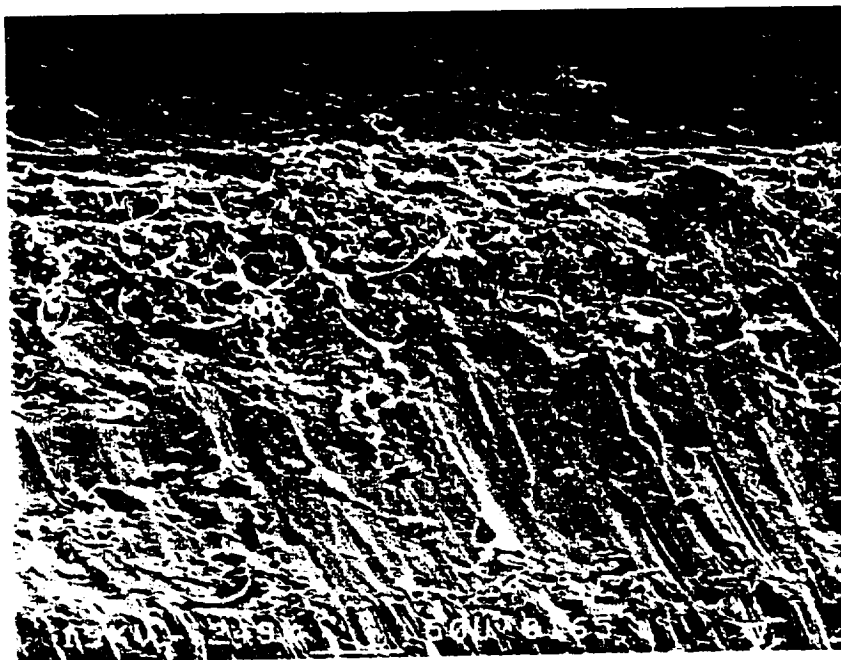
Galled & Smeared  
Material on the Drive  
Face

Smeared Base Metal

Worn Drive Face

**Figure 2:** Areas of severe galling and smearing of the base metal.  
 TOP: SEM photo at 135x near the tip of a tooth on the 718 driven gear.  
 BOTTOM: SEM photo at 248x near the root of a tooth on the 718 drive gear.

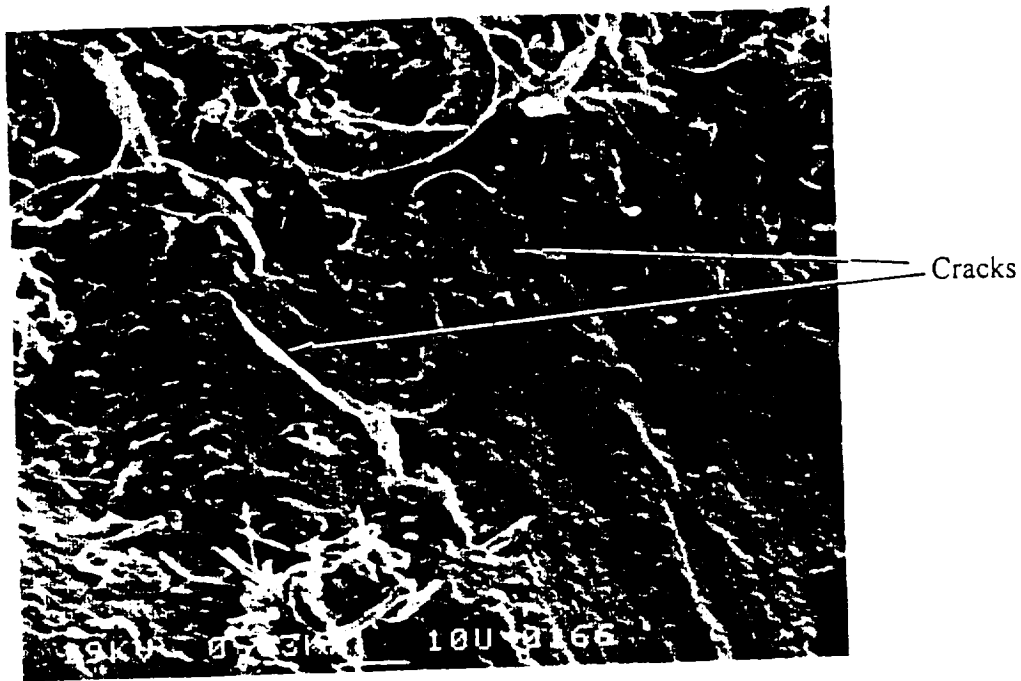
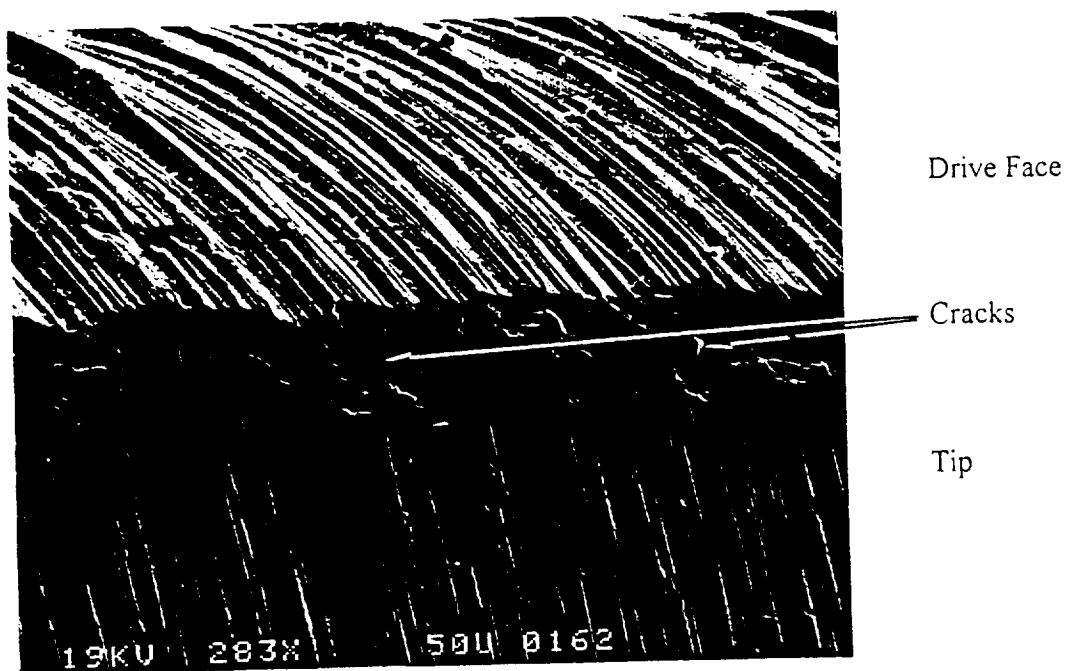
The examination of both the Inconel 718 and Stellite 6B gears in the areas near the edge of the removed boride showed cracks were present. These cracks likely indicate the coating was not sufficient to withstand the gear loading.

**Figure 6:** SEM photos showing cracking of the boride layers adjacent to the worn areas on the 718 drive gear.  
 TOP: 830x near the root of a typical tooth.  
 BOTTOM: 283x at the tip of a typical tooth.
